NASA Technical Memorandum 85831

**FIELD REPAIR OF AH-1G HELICOPTER
WINDOW CUTTING ASSEMBLIES**

Laurence J. Bement

May 1984

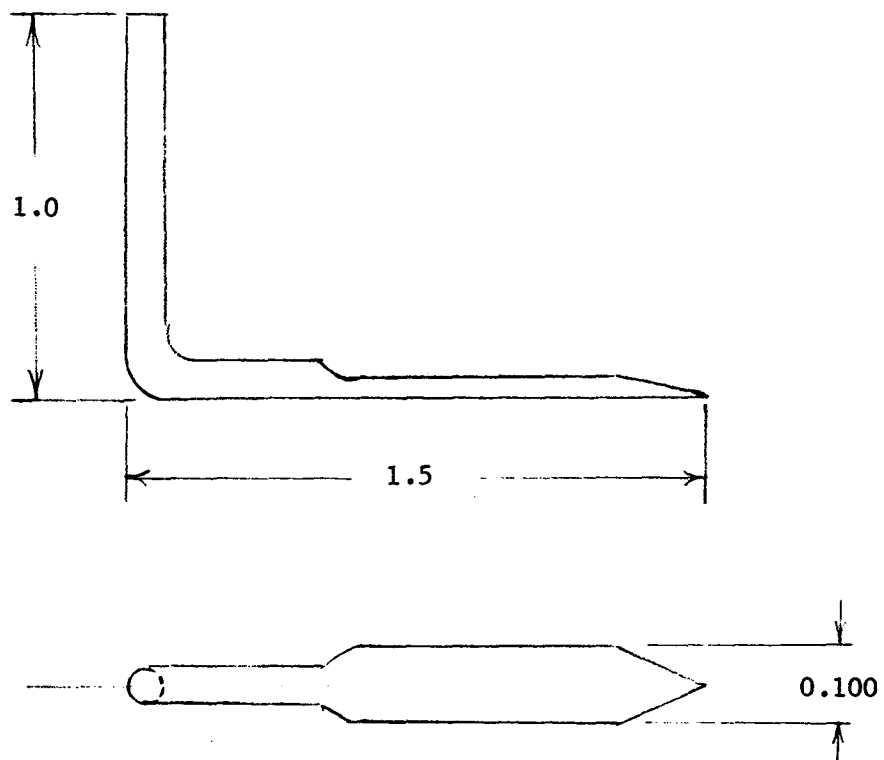
In an attempt to scope the relative magnitude of the problem of explosive cord-to-acrylic separation, a 15-aircraft inspection (60 windows and doors) was conducted. The nondestructive inspections used an optical method and a tool that was developed for this effort. The optical method was a lens system that was focused on the surface of the explosive cord, and then the fixed lenses were displaced to refocus on a piece of paper pressed against the surface of the acrylic, opposite the explosive cord. The displacement of the lenses was the cord-to-acrylic gap. The inspection tool, shown in figure 2, provided a go/no-go approach. The flattened leg (the flattened area against the acrylic with the 1-inch leg perpendicular to the surface) was slipped between the acrylic and rubber extrusion; this shape allowed the bulbous areas of the rubber extrusion to be pushed aside without damage. The 1-inch leg was then rotated against the acrylic to place the 0.100-inch blade across the explosive

cord-to-acrylic gap. A second inspector viewed the tool through the acrylic to determine if contact had been made with the explosive cord. Other tools with different blade widths could be used to establish any gap size.

Figure 2.- Inspection tool: insert flattened leg between explosive cord and acrylic and rotate 1-inch leg down to position the 0.100 dimension perpendicular to the acrylic.

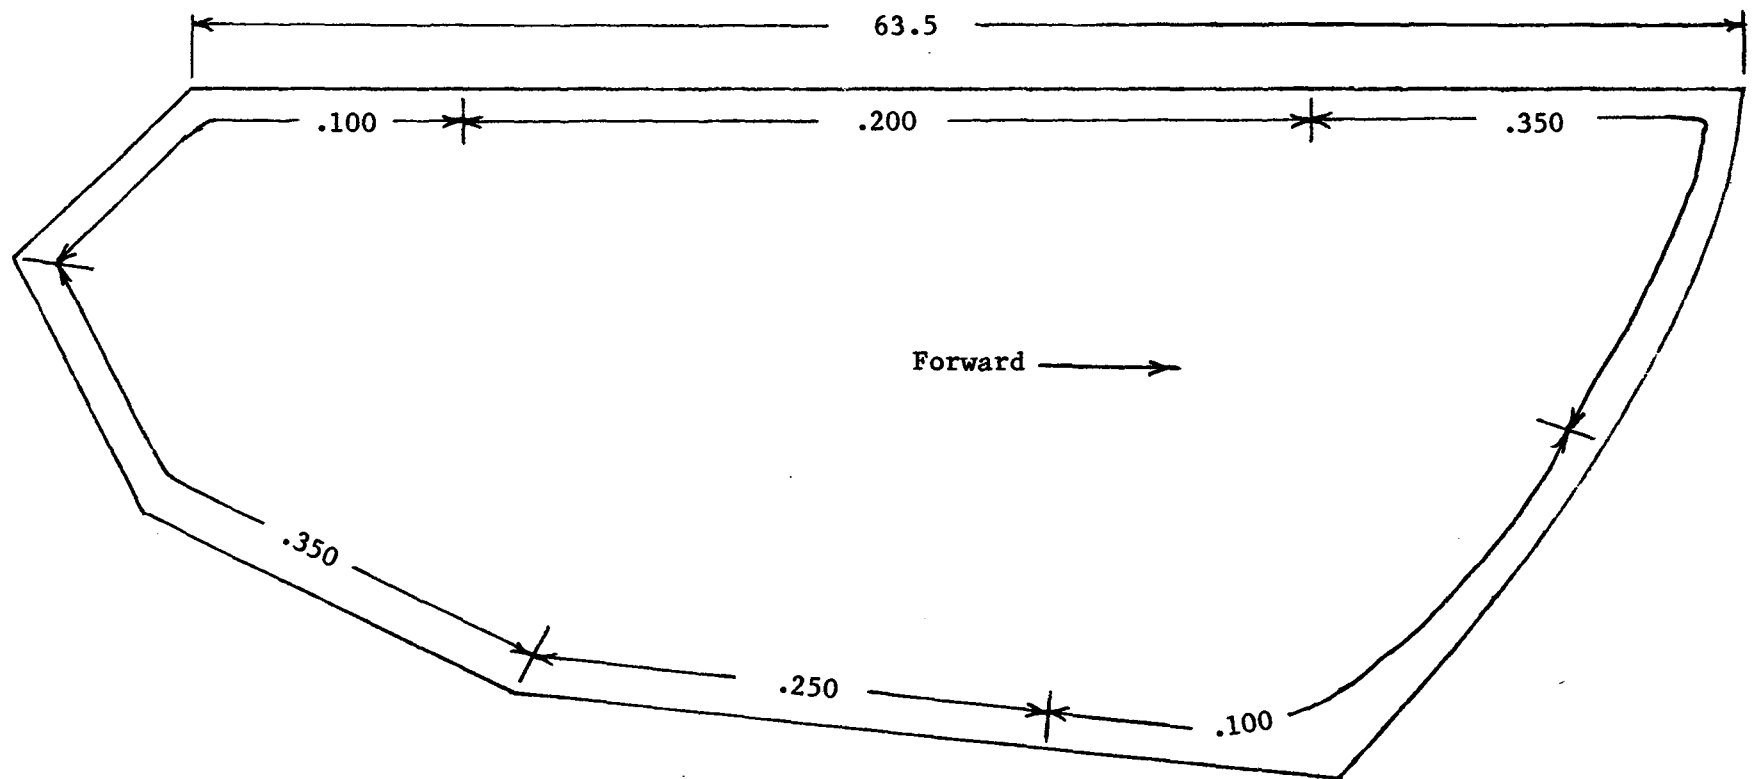
The results of test 3, which employed a variable gap (large gaps at the corners) and a 1.5-inch RTV bead width, are shown in figure 10. The acrylic was not jettisoned, nor did much cracking occur through the control area. The acrylic-to-frame interface around most of the periphery was not obviously cracked.

Figure 3.- Explosive cord to acrylic separation distances for Test 3.

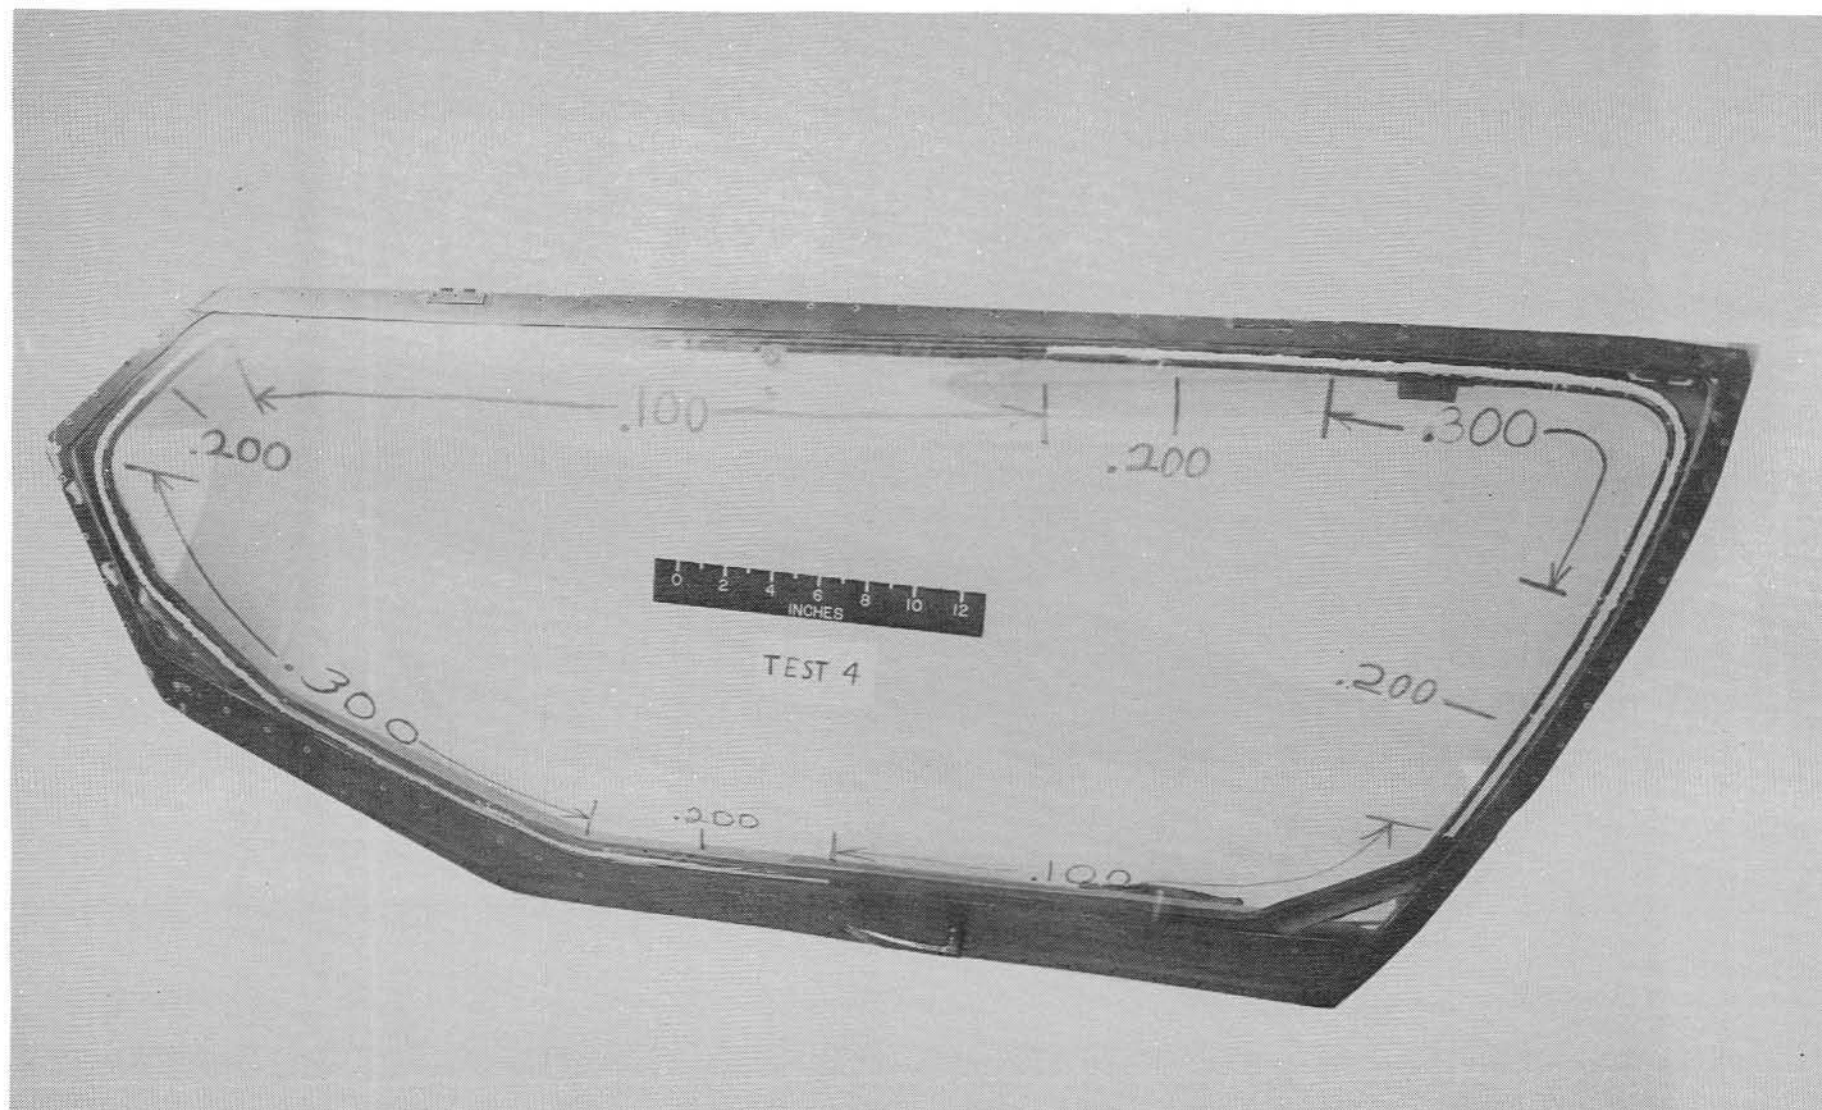
Test 4 was conducted with the variable gaps shown in figure 4. The door was fully assembled to allow installation of the RTV in a simulated field condition. Care was taken to avoid overlap of the RTV onto the frame in areas, such as that shown in figure 5. RTV was installed only in gaps that were greater than 0.100 inch. The RTV was installed using a cartridge, as shown in figure 6. The cartridge tip was preheated to a softened condition and flattened to allow insertion past the bulbous areas to the explosive cord. The RTV was ejected from the cartridge, using a hand-operated gun, which maximized the control of the flow to coordinate with tip movement. The RTV bead was carefully controlled to a maximum width of 0.25 inch and was prevented from contact with the frame, as shown in figure 7. In all RTV installations, the RTV was cured 16 hours or more.

Figure 4.- Explosive cord to acrylic separation distances for Test 4.

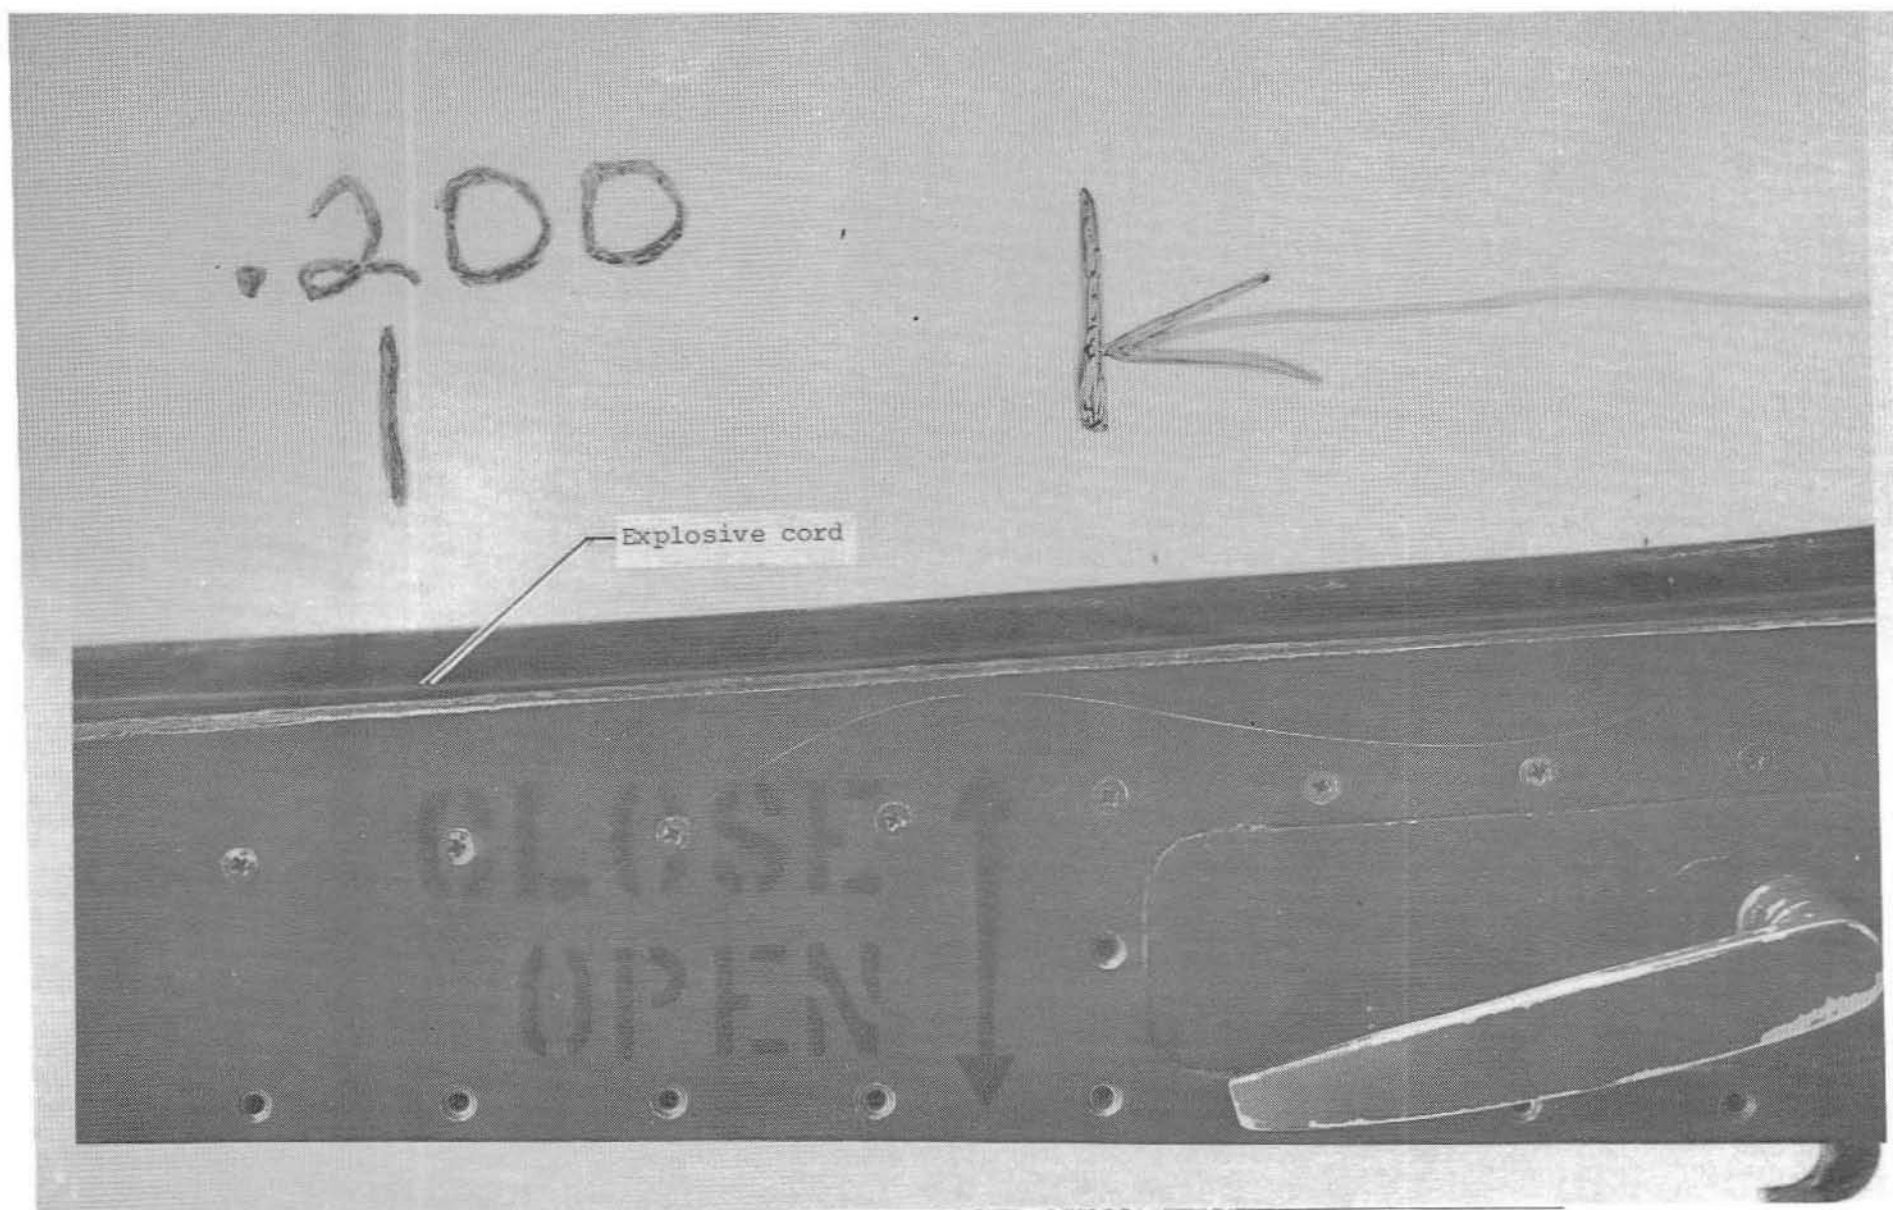
Figure 5.- Illustration of close proximity of explosive cord with acrylic fiberglass frame before installation of RTV.

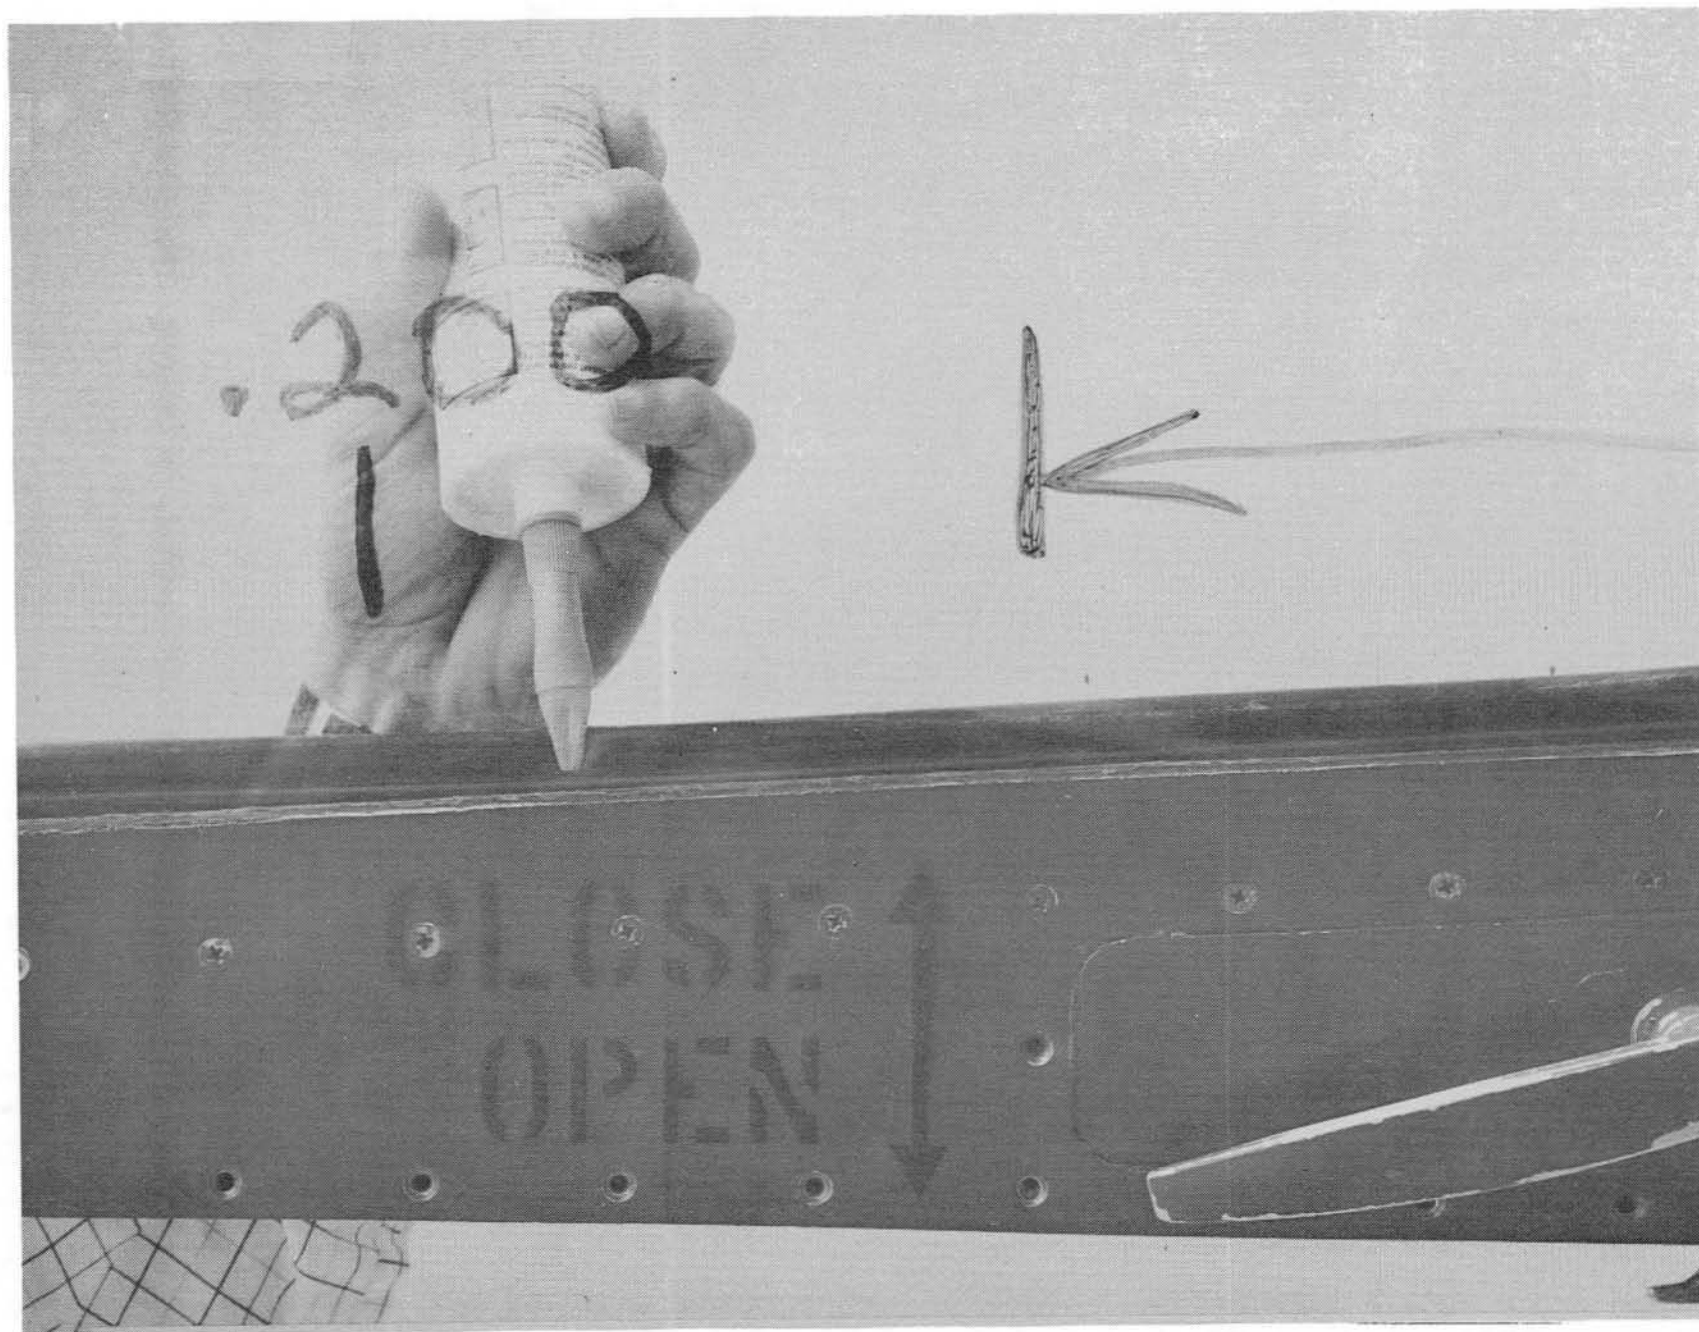
Figure 6.- Installation of RTV, using field approach of inserting flattened tip over explosive cord. The RTV was injected with a hand-operated gun.

The repair approach selected was to install room temperature vulcanizing silicone compound (RTV) between the explosive cord and the acrylic without disassembly of aircraft components. The tip of an RTV cartridge was flattened to allow insertion in the gaps, and hand-operated guns were used to control the flow of RTV with tip motion. The RTV bonds the explosive cord assembly to the acrylic to prevent further gapping problems. On functioning, the RTV couples the explosive pressure wave into the window, rather than allowing rapid attenuation in air gaps. If a window needed replacement, the RTV would be cut from the acrylic, and following installation of a new acrylic, the RTV rebonded.

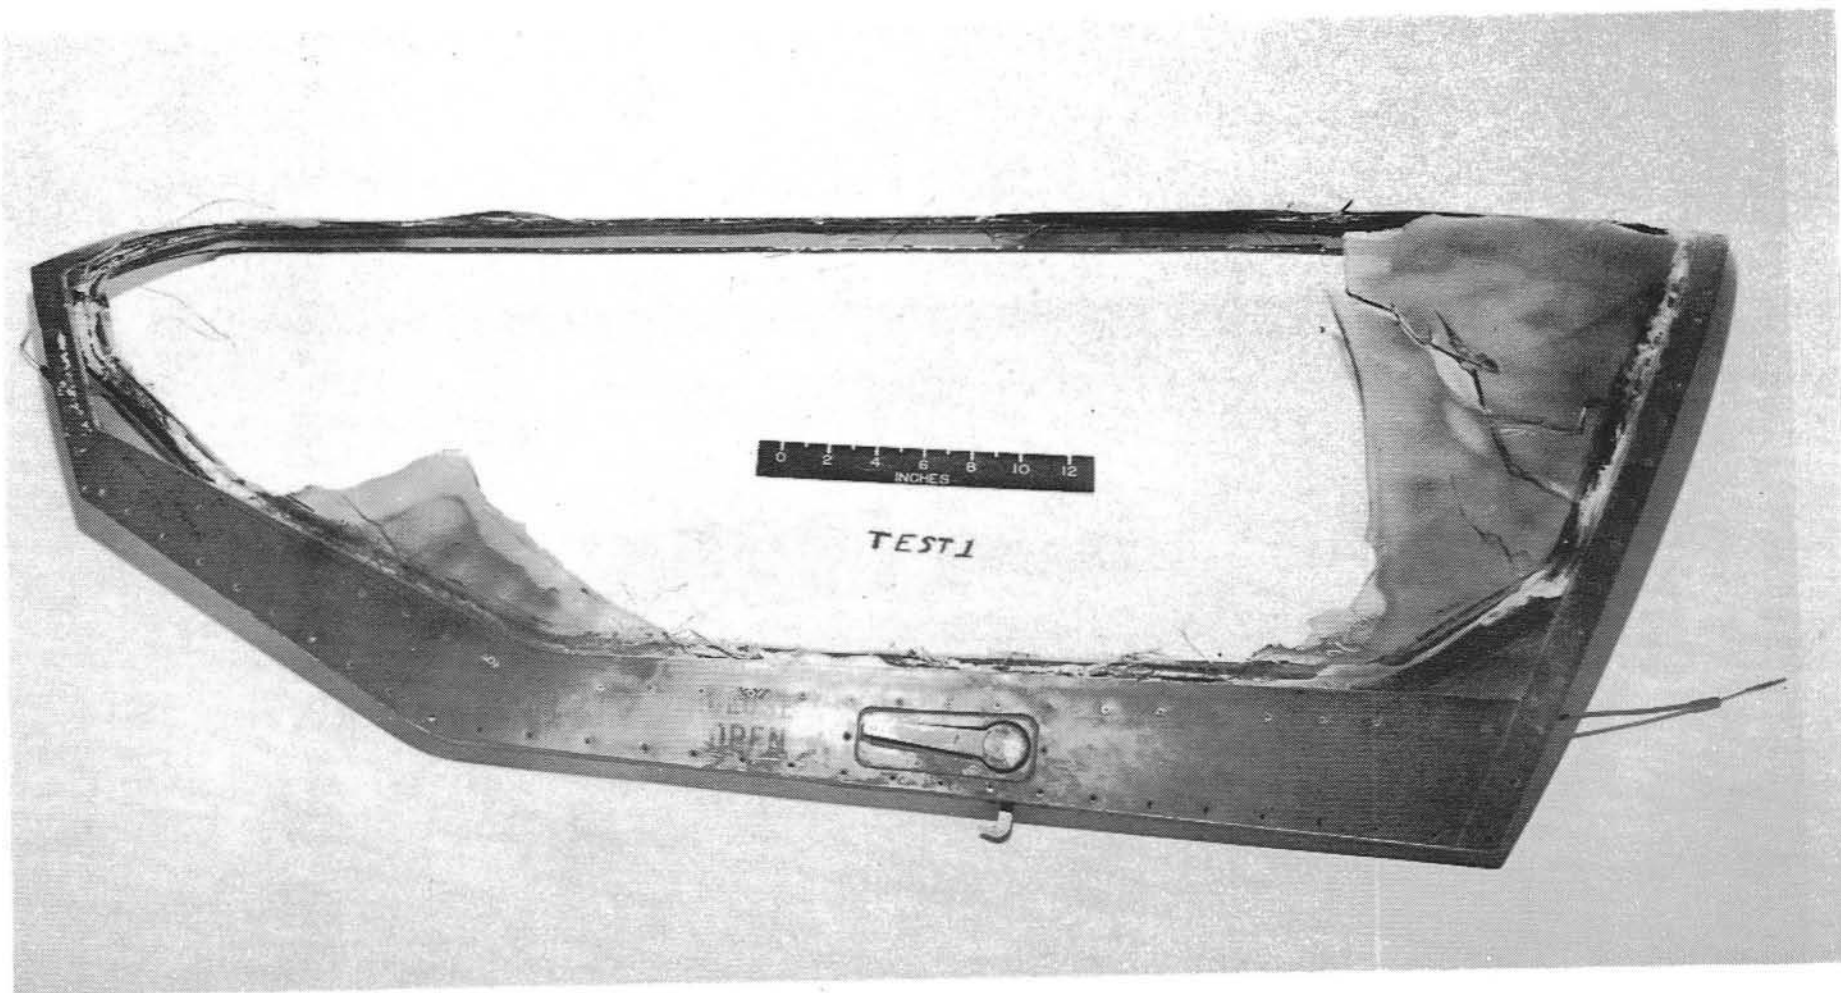
Figure 8.- Functional results of Test 1.

The results of test 1, which employed a constant peripheral gap of 0.200 inch with a 0.5-inch RTV bead width, are shown in figure 8. Approximately 80 percent of the area was jettisoned. The acrylic was sheared at the acrylic-to-frame interface, that is, the point at which a fiberglass frame was bonded to the acrylic.

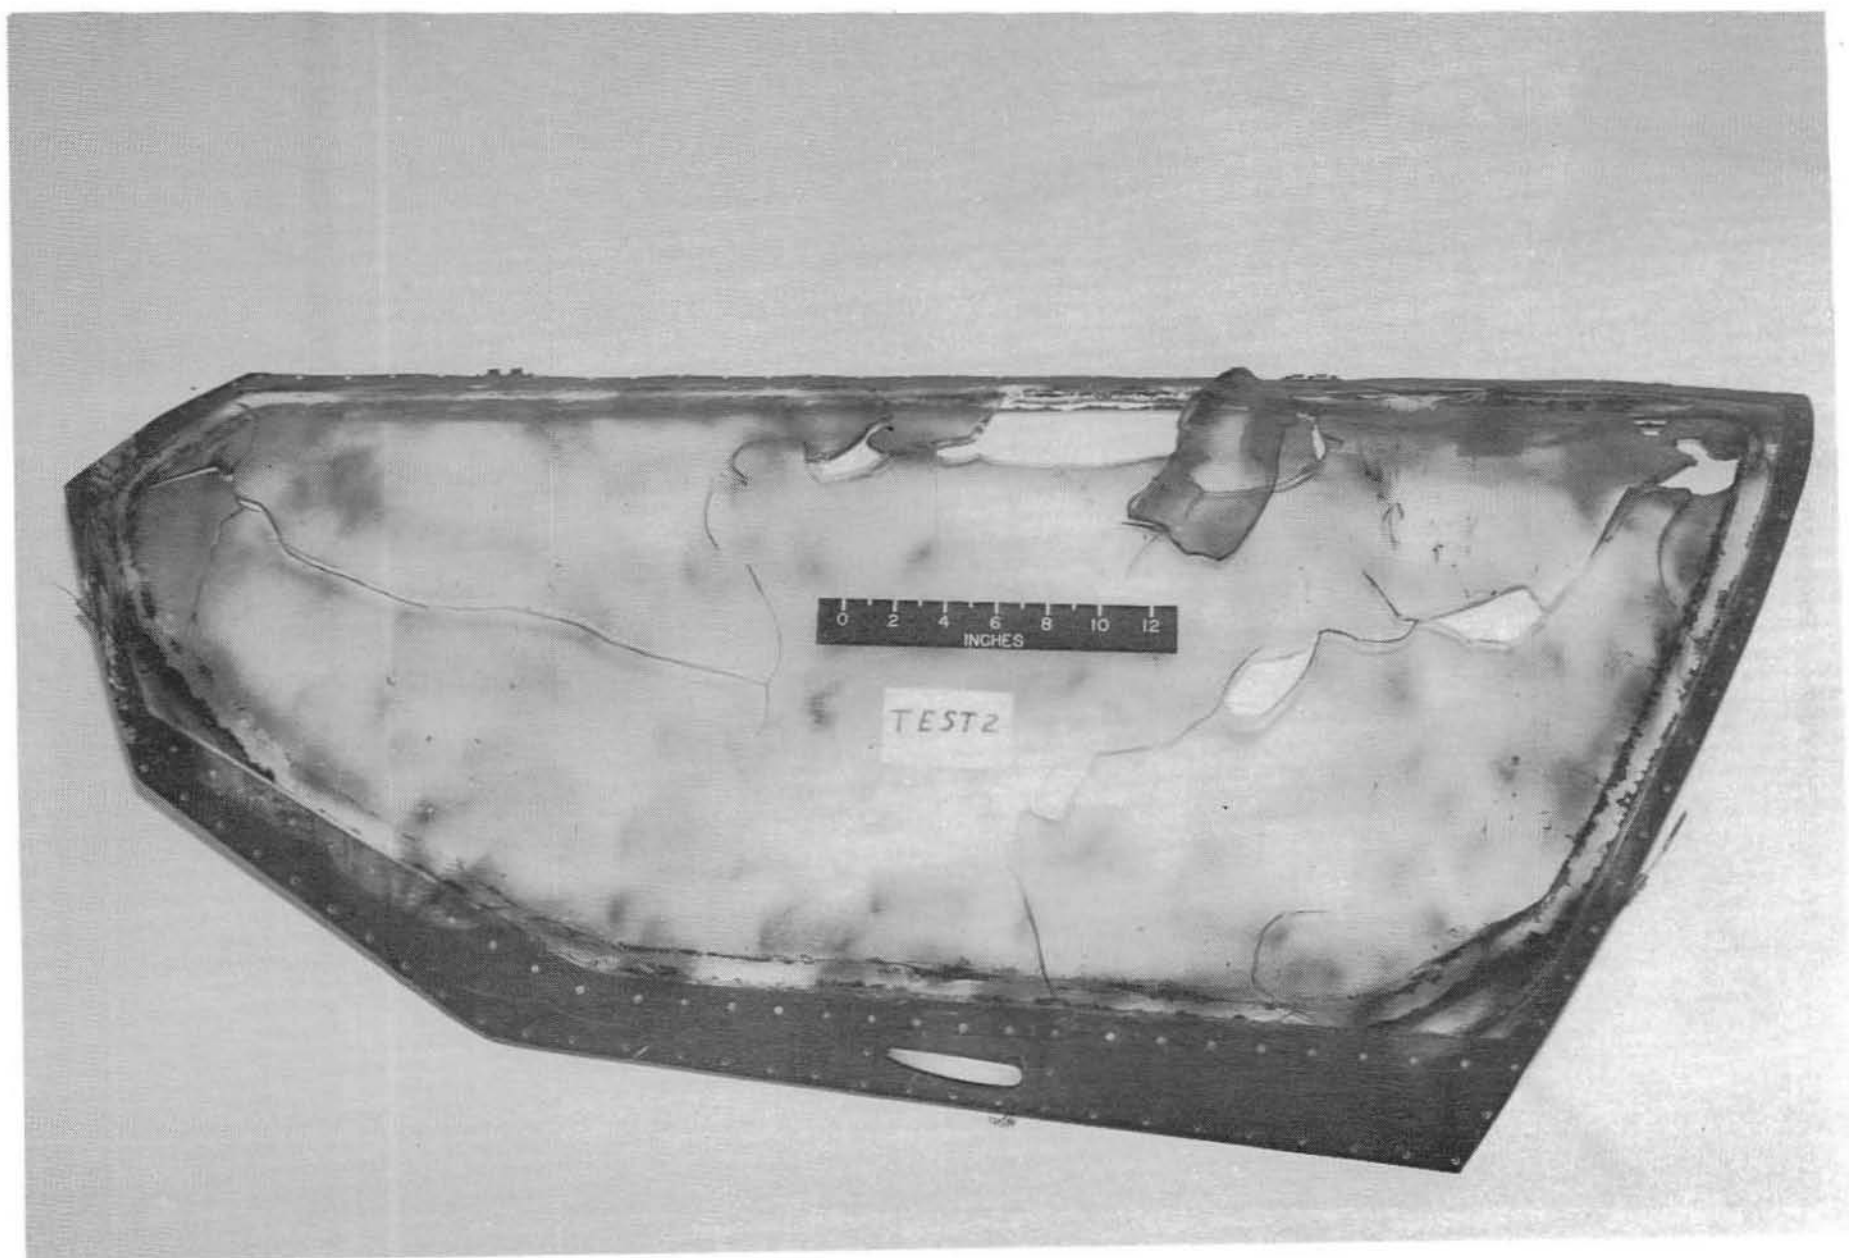
Figure 9.- Functional results of Test 2.

The results of test 2, which employed a constant 0.300-inch peripheral gap with a 0.75-inch RTV bead width, are shown in figure 9. The acrylic was not jettisoned except for a small portion at the top. In fact, this piece was hanging by a less than 1-inch long RTV bond of the acrylic to the rubber extrusion. Central cracks indicated that the acrylic had been considerably flexed. Appreciable cracking was evident at the interface between the fiberglass frame and the acrylic.

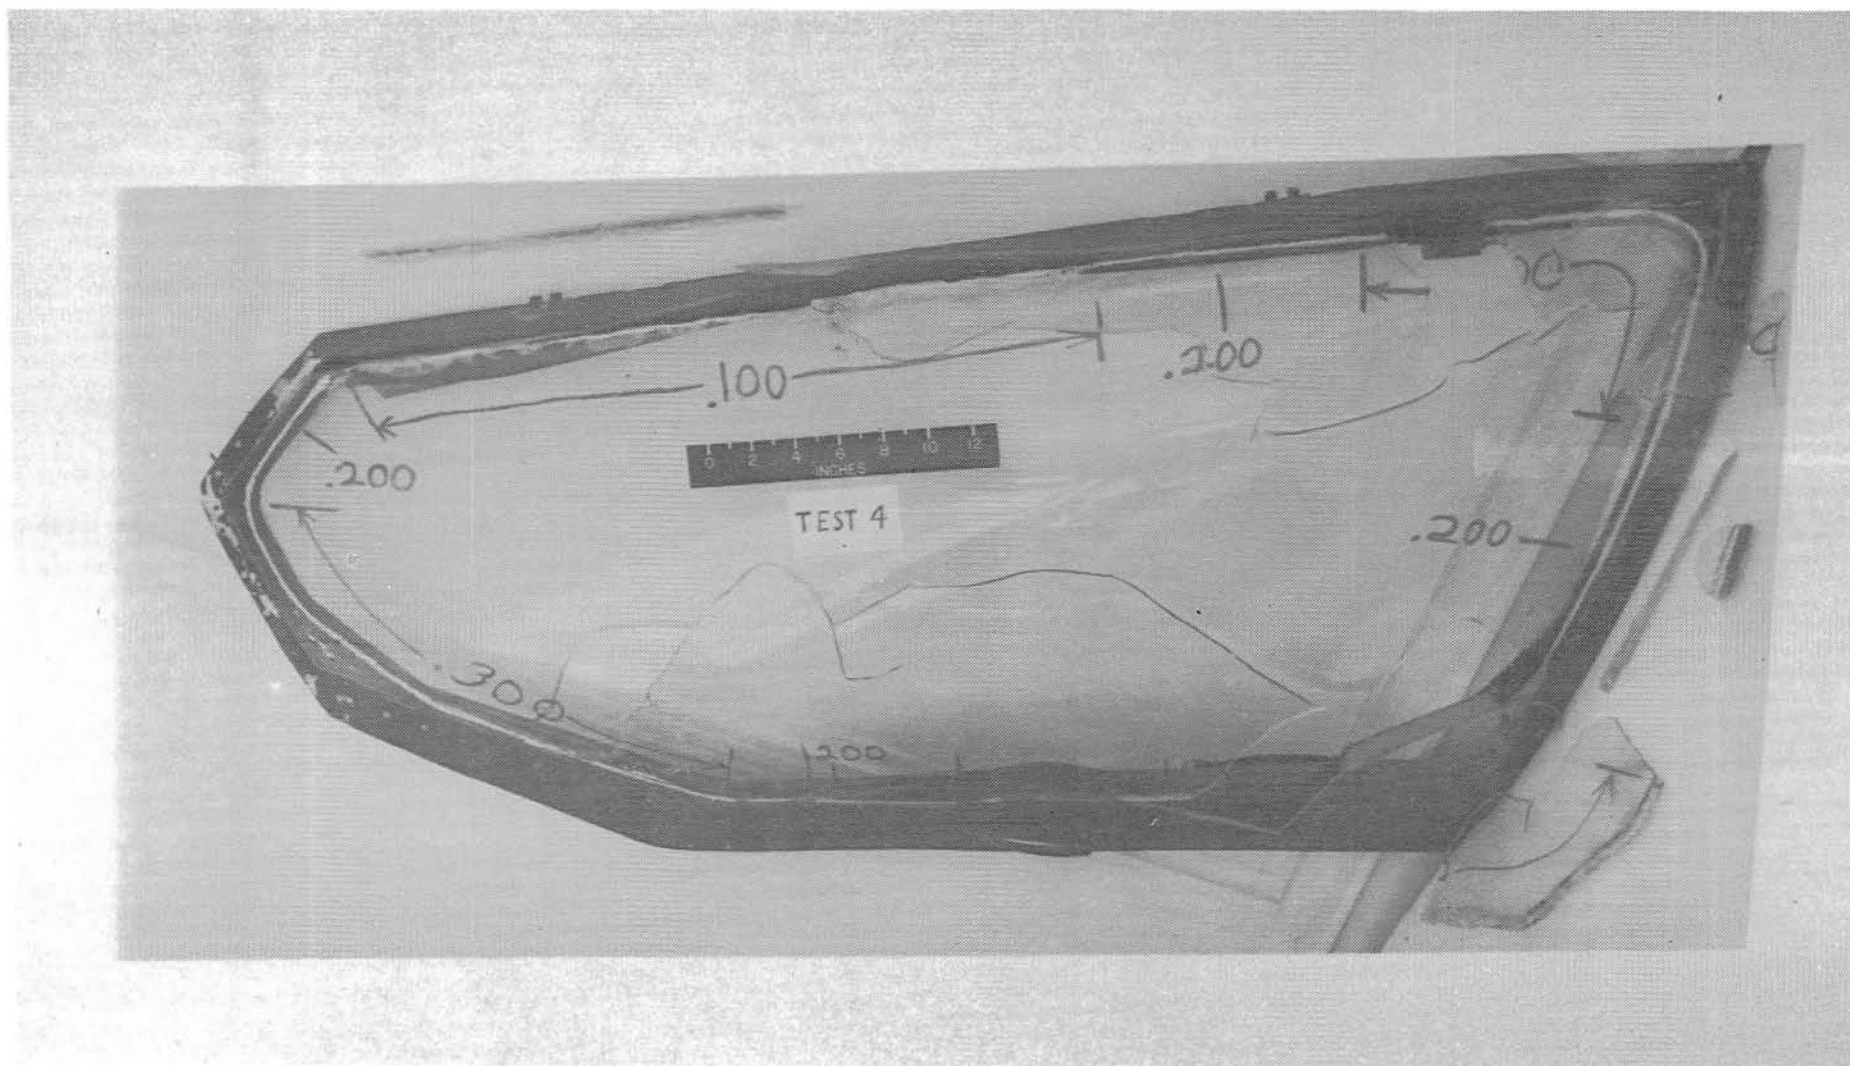
Figure 11.- Functional results of Test 4.

The results of test 4, which employed a variable gap to represent a typical aircraft condition, including lengths in which no RTV was installed, and a carefully controlled 0.25-inch or less bead width, are shown in figure 11. The entire periphery was either severed, as expected in the gaps that were 0.100 inch, or fractured at the interface between acrylic and the fiberglass frame. Figures 12 and 13 show more detail on this severance: the acrylic sheared at the frame in the lengths in which the RTV was applied, and the acrylic was fractured on the centerline of the explosive cord, where no RTV was applied.

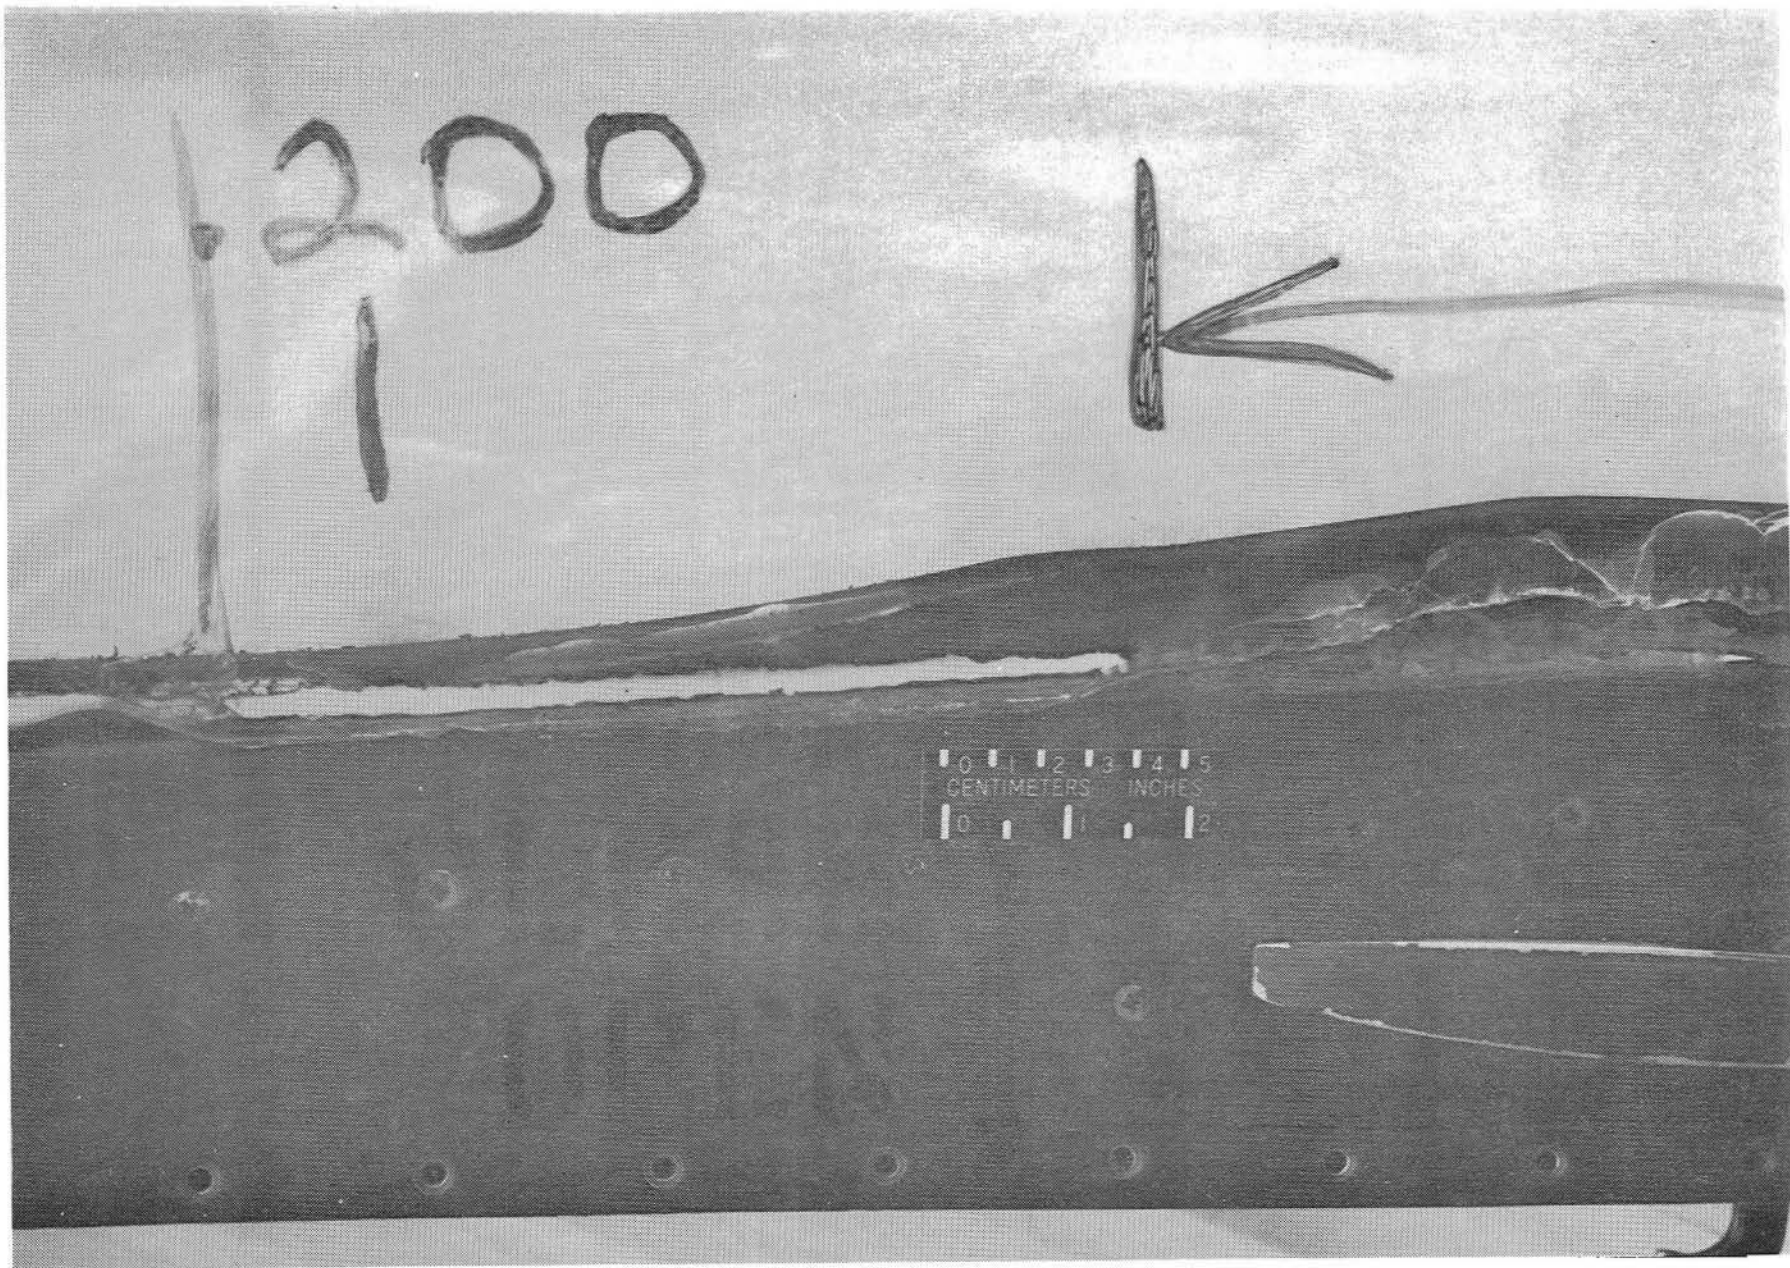
Figure 12.- Closeup of lower, center position explosive severance in Test 4, showing fracture of acrylic at frame on left and on centerline of the explosive on the right (no RTV). See test setup in Figure 7.

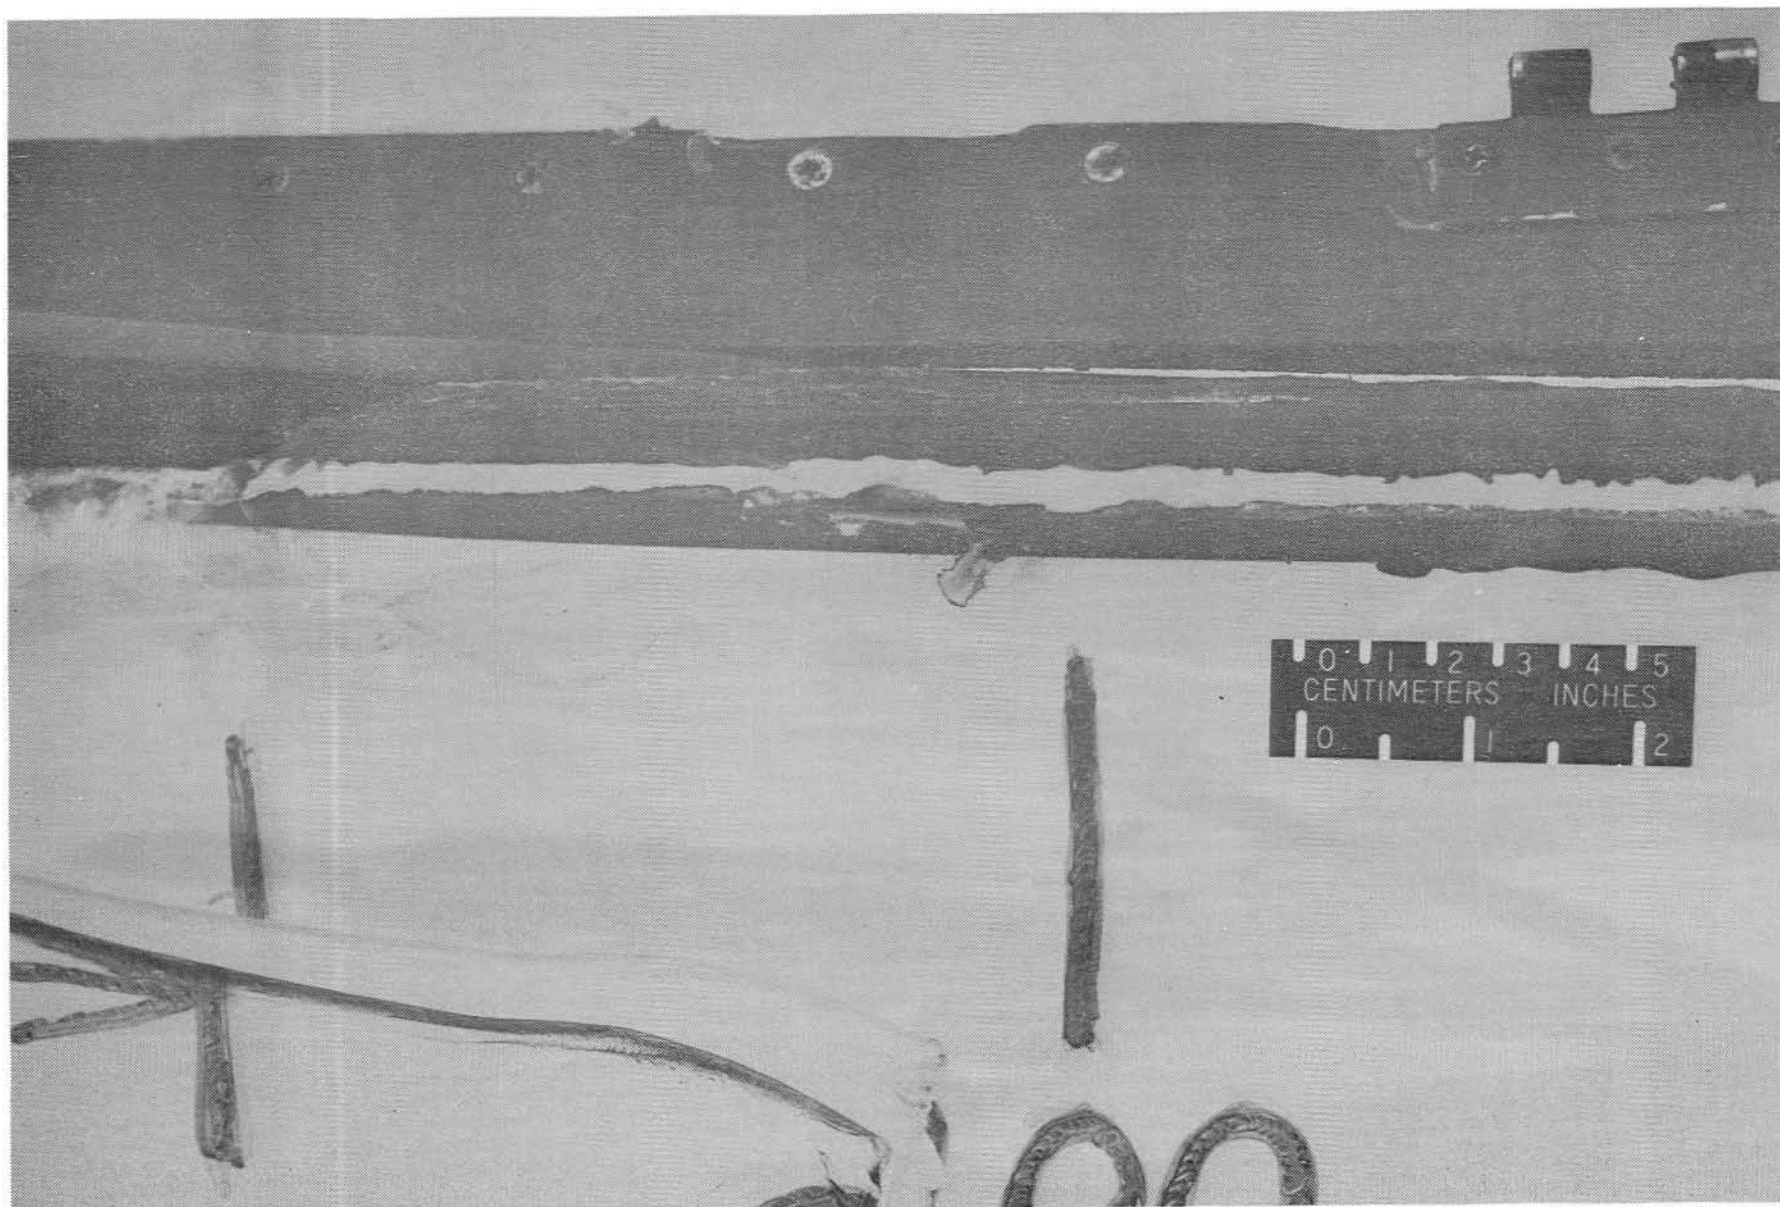
Figure 13.- Closeup of upper, center position explosive severance in Test 4, showing fracture of acrylic on explosive centerline on left (no RTV) and at the frame on the right.

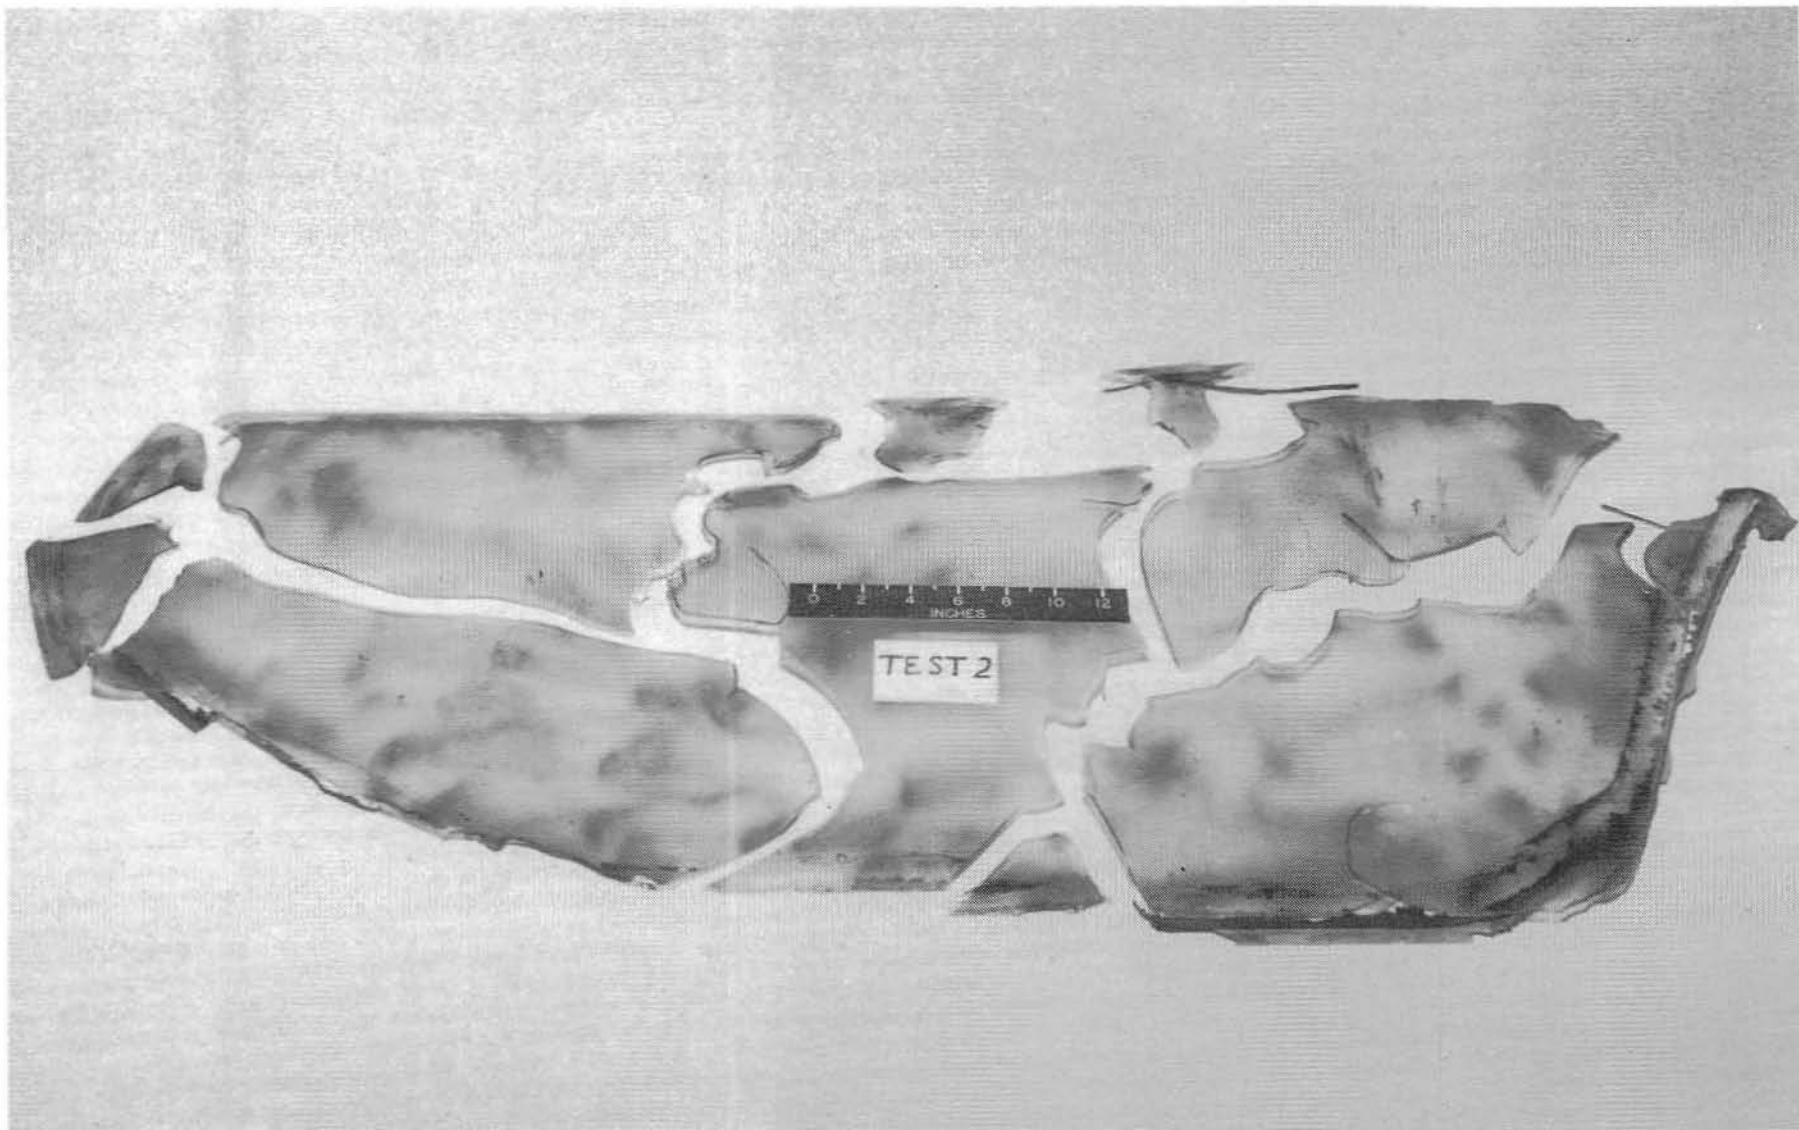
Figure 14.- Acrylic pushed out of the frame in Test 2.

The pushout testing revealed the actual effectivity of the explosive severance and fracture induced in tests 2, 3, and 4. For test 2, a 12-pound thrust on the center of the acrylic ejected the major portions (center and upper right and upper

left areas, shown in fig. 14). The two remaining areas required approximately 100 pounds to push out. The entire periphery was severed at the acrylic-to-frame interface. The areas hinged on the RTV bond line, and in most cases the window cutting assembly frame was broken to clear the area. The pushed-out area for test 3 is shown in figure 15. A 125-pound thrust released the major area. The periphery was 98 percent severed at the acrylic-to-frame interface; an 8-inch length in the lower, center area was not severed. The remaining areas required thrusts of 90, 30, and 85 pounds to clear more than 95 percent of the area. For test 4 with the closely controlled RTV installation, no more than 4 pounds was necessary to push out any portion of the acrylic. The acrylic was severed around the entire periphery. The RTV bonds were all that retained the acrylic in position. Figure 16 shows the pushed-out acrylic.
